Streetlights in Refugee Settings

Case Study: Bangladesh

Author: Ronan Ferguson, Director, SDG7 Consulting

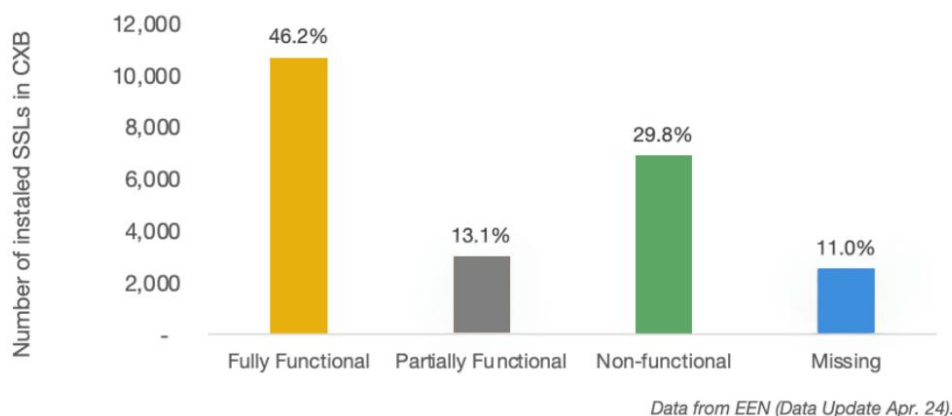
Figure 1 Functionality of SSLs in CXB ¹

While many of these installations have improved perceptions of safety and nighttime access, particularly for women and girls, fewer than half of the SSLs remain fully functional (see Figure 1).

To meet established coverage standards for nearly 190,000 households and critical camp infrastructure including latrines, health centres, and pathways, an estimated 37,700 SSLs are required. With approximately 10,700 fully operational SSLs, a significant functionality gap of around 27,000 units persists. Reactivating the 9,900 non-functional SSLs represents a substantial opportunity to improve coverage without additional installations.

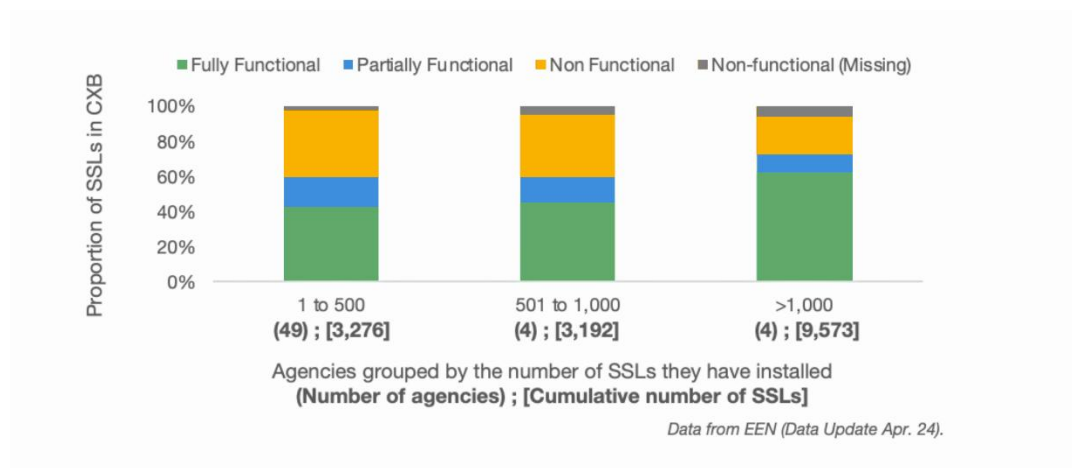
Figure 5 Impact of agency installation numbers on functionality

Implementer experience also plays a role. Agencies that have installed more than 1,000 SSLs each – collectively responsible for over 9,500 streetlights – report a 62% functionality rate. This is well above the average for smaller implementers (43–45%) as shown in Figure 5. These findings highlight the value of economies of scale and the potential for knowledge sharing between agencies.
